Active Faults and Nuclear Power Plants

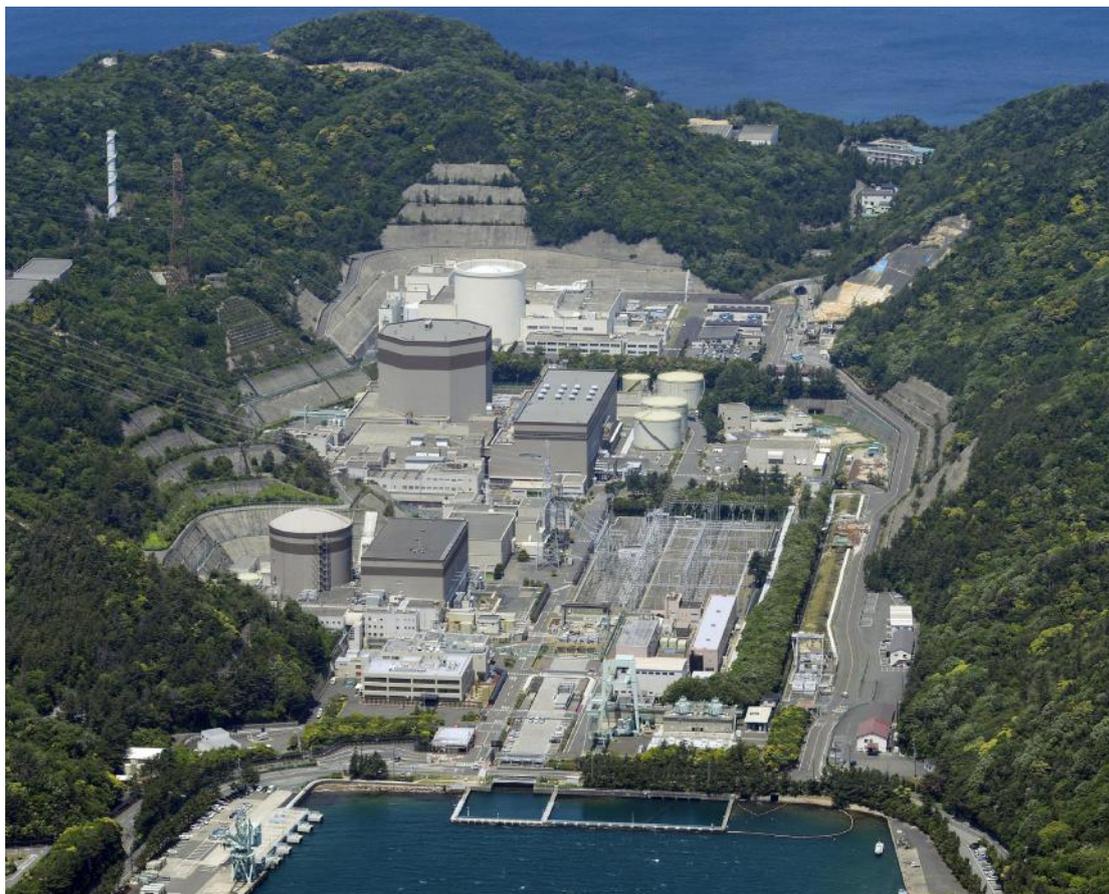
Figure 1: The Tsuruga NPP, looking to the north-west, with Urasoko Bay in the foreground and the Japan Sea in the background. The upthrown side of the active Urasoko Fault forms the prominent scarp to the right of the complex and the yellow-brown excavation to the top-right of the picture indicates the scale of one of the trenches used to expose the Urasoko fault and the 'D-1' and 'K' faults. The No. 2 reactor, under which the 'D-1' fault passes, is the large, octagonal building to the left-centre of the site.

Tsuruga is an historic port lying at the head of the large, sheltered anchorage of Tsuruga Bay. Two major nuclear complexes are located on the mountainous peninsula that forms the western side of the Bay. One of these, the Tsuruga NPP, has two reactor units, including the oldest functional nuclear power station in the country. They lie in a deep valley that extends southeastwards to form an embayment on the peninsula – Urasoko Bay (Figure 1). The eastern side of the valley and Urasoko Bay are the scarp slope of a major active fault – the Urasoko Fault, with a mapped length of about 10 km, but possibly extending further, south across Tsuruga Bay and northwards into the Japan Sea. The evidence suggests that this fault has moved repeatedly in the late Pleistocene, with a recurrence interval of about 4000 years. The foundations of both NPP reactors lie only about 200 m to the west of the fault. The Urasoko Fault was not considered to be active when the NPP was sited in the 1970s, but it has appeared on sequential updates of Japan's active fault map since 1991, as either 'active' or 'possibly active'. The impact on plant safety of the Urasoko fault was evaluated during the seismic re-evaluation (back check exercise) mandated by the then regulator, NISA, in the period from 2007-2010.

However, it is not the Urasoko Fault that has been causing problems over the last year for Japan Atomic Power Company (JAPC), the operators of Tsuruga NPP. An inspection by experts commissioned by the NRA concluded that a bedrock fault (the 'D-1 fault') that was already known to lie in the granitic rocks that lay directly beneath the base mat of the Unit 2 reactor might be connected to the Urasoko fault and might move in sympathy with it – and should consequently be defined as 'active'. According to NRA's regulations, an active fault beneath critical facilities means that they should not be operated. In fact, this type of criterion is intended to avoid such a situation arising when a new NPP is sited. Here, NRA was considering 'back-fitting' the regulation to an old facility, with Tsuruga now being only one of several NPPs and other nuclear facilities in Japan that are threatened with closure as a consequence: the Ohi, Higashidori, Mihama and Shika NPPs, together with the prototype Fast Breeder Reactor, Monju.

The trenching work exposed more fault structures than were known about from the original foundation works of the NPP. The NRA experts considered that one of these, the K-fault, was also active and could extend beneath reactor Unit 2. The key evidence for the age of last movement of both the D and the K faults came from several deep exposures in the trenches that allowed plotting of the extent of upward fault penetration into the sediment layers. By seeing which layers had been penetrated and the geometry of the penetrations it was possible to conclude when the latest movement had occurred. For both features, it was clear that there was no evidence for movement in the last 120 – 130,000 years. Indeed, the D-1 fault, which had been known about since Unit 2 was under construction, appeared to be considerably older than this, and the K-fault was seen to trend towards a termination well before it approached Unit 2.
