The Hokkaido Earthquake: a (very) preliminary analysis revision 1

September 06, 2018, 03:08 JST

Woody Epstein, ARS

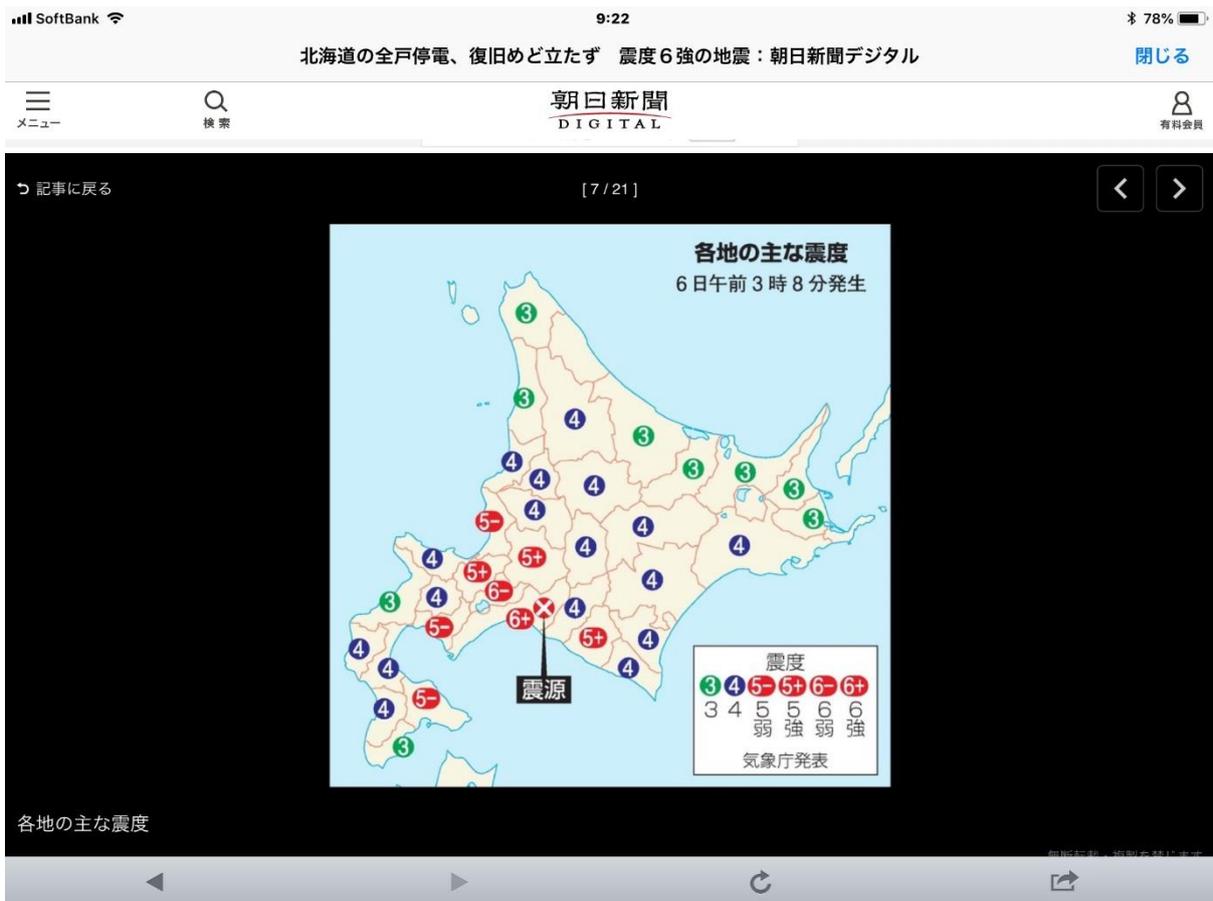
Map of Hokkaido indicating JMA Intensities (Shindo)

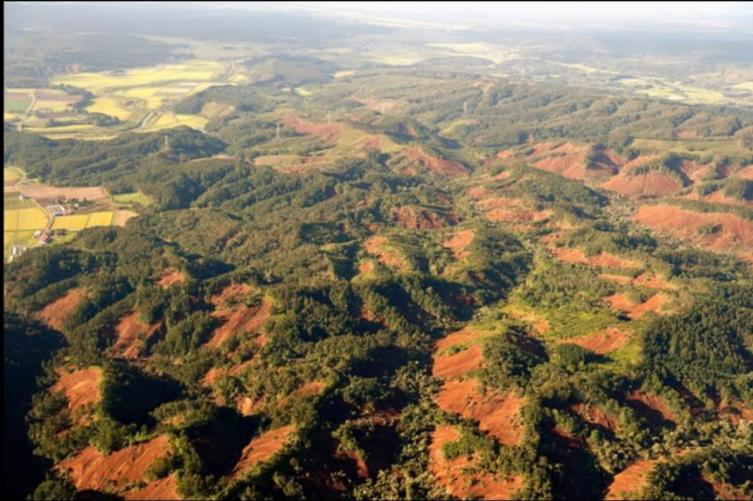
[6/21]

周辺の山一帯が土砂崩れを起こし、山肌が露出していた＝2018年9月6日午前7時21分、北海道厚真町、朝日新聞社機から、山本壮一郎撮影

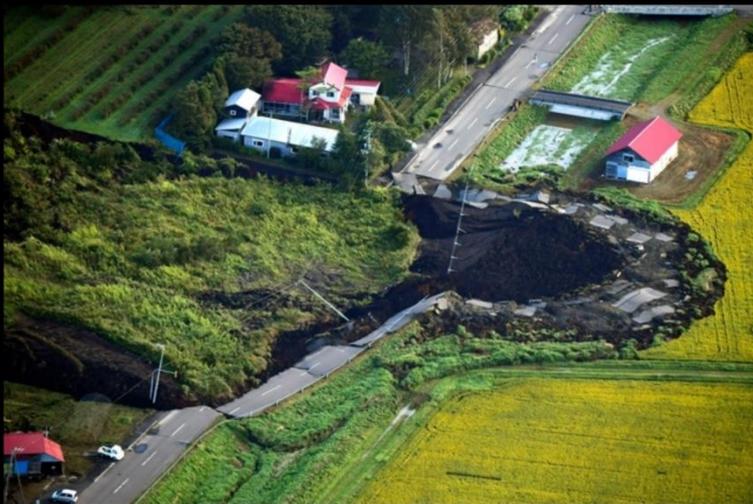
[9/21]

陥没した車道＝2018年9月6日午前7時17分、北海道厚真町、朝日新聞社機から、山本壮一郎撮影

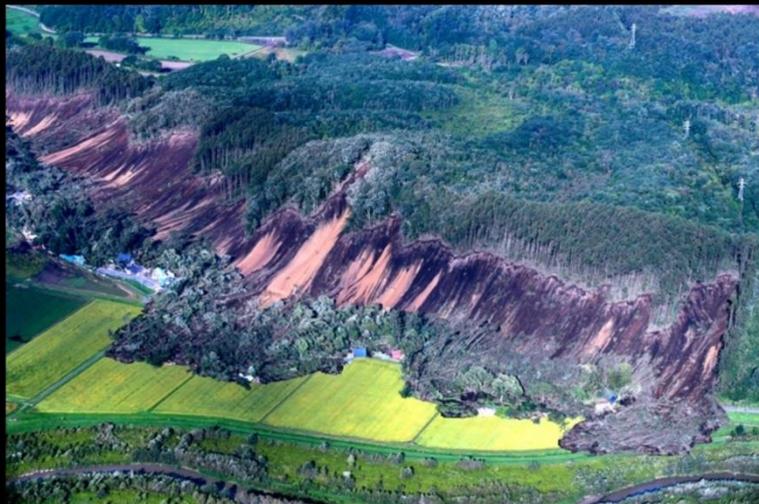
[1 / 21]

地震で山肌が崩れ住宅が土砂に巻き込まれていた＝2018年9月6日午前7時18分、北海道厚真町、朝日新聞社機から、山本壮一郎撮影

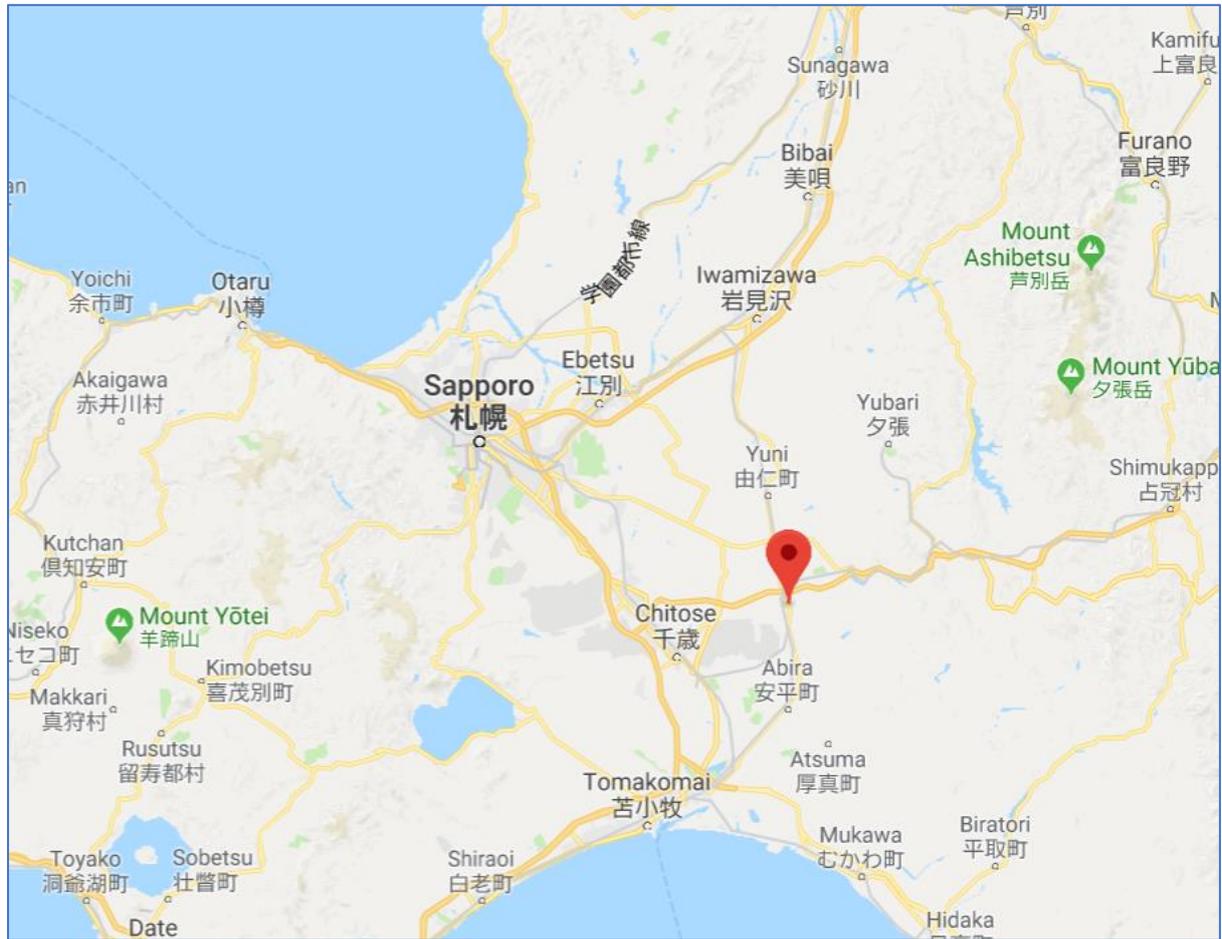
The city of Oiwake, where the highest ground motion was recorded. Near Chitose airport which was closed because the roof fell.

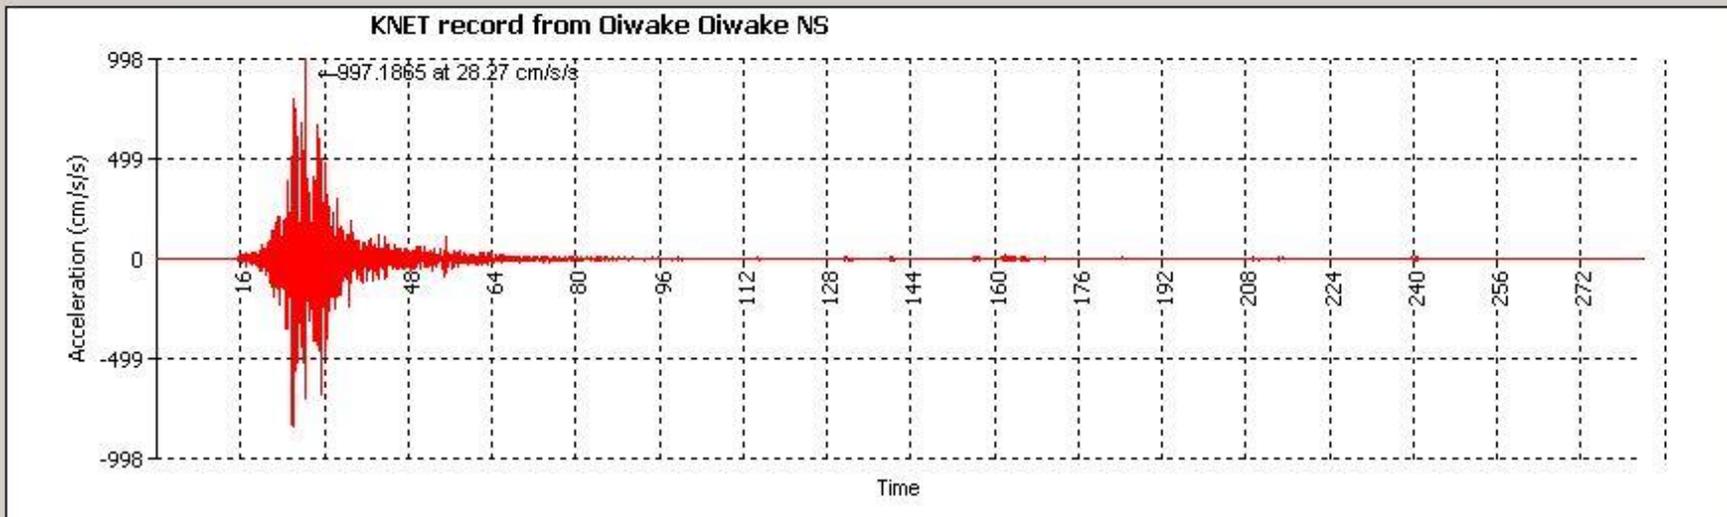
Average Acceleration Response Spectra

JMA Instrument Intensity: 6.40

Direction	PGA g	Max SA	CAV	Arias	ZPA g	2 to 10 Hz	10 to 20 Hz	20 to 33 Hz
1	North/South	1.0165	3.5727	3.3985	15.4889	1.0148	2.7704	1.2512	1.0939
2	East/West	0.9163	3.7217	3.2492	13.0401	0.9148	2.7140	1.7016	1.2414
3	Up/Down	1.6116	4.7343	1.7059	7.4832	1.6059	2.4512	3.0857	1.9911

JMA Effective PGA: 536.07 gal

CAV SRSS: 5.0017

- The PGAs at Oiwake were all greater than 0.90 g, with 4 of 6 directions greater than 1.0g, much greater than that experienced in all strong motion records during the 3/11/11 Great Eastern Japan Earthquake. Many, many landslides.
- Much structural damage and will report about that in the next revision.

- The calculated JMA intensities (called Shindo) were 6.73 and 6.40 on a scale of 7.0 ... extraordinarily high, and again, stronger than anyplace during 3.11.11.

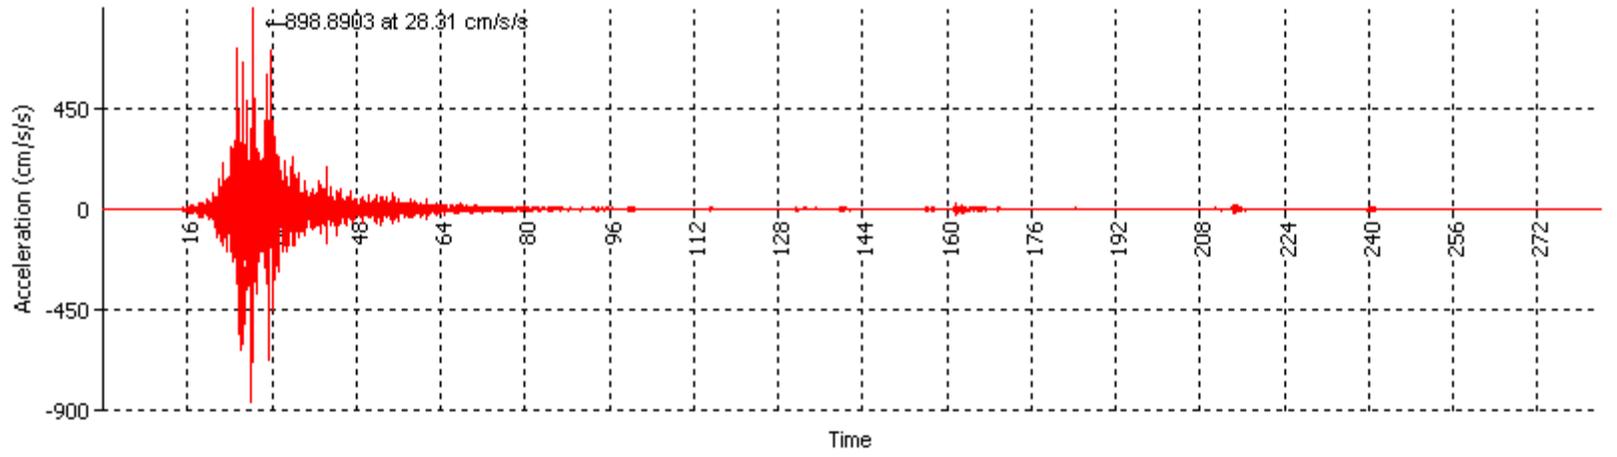
KNET record from Oiwake Oiwake EW

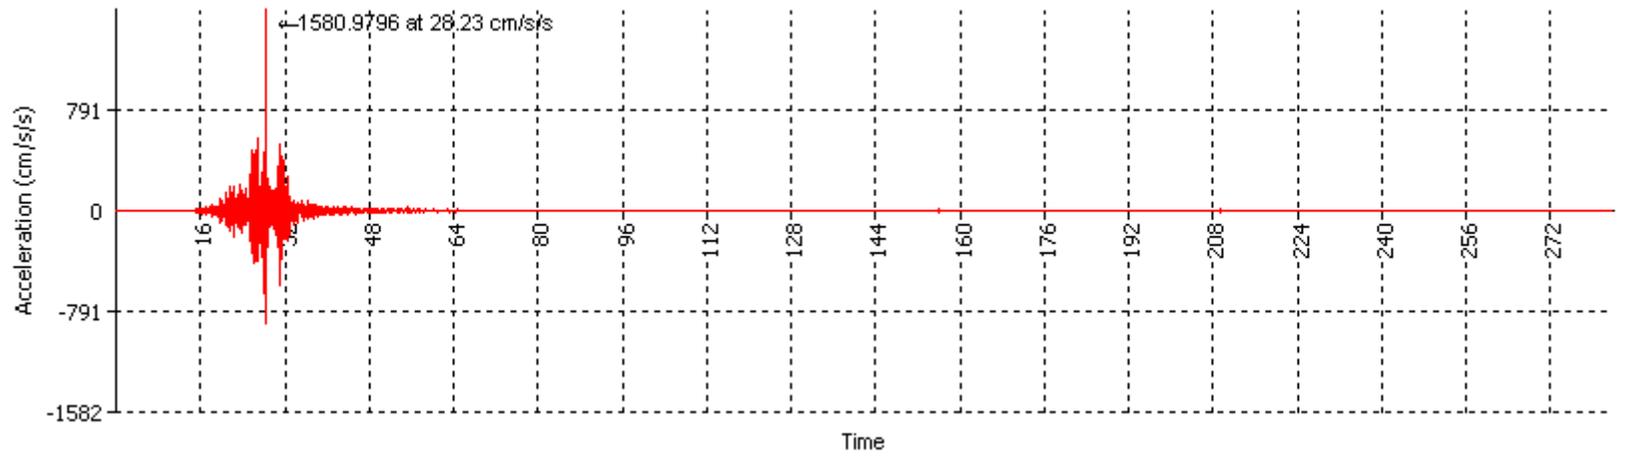
KNET record from Oiwake Oiwake UD
