The Hokkaido Earthquake: photos and analysis (photos by Jiji News Service)

September 06, 2018, 03:08 JST

Woody Epstein, ARS

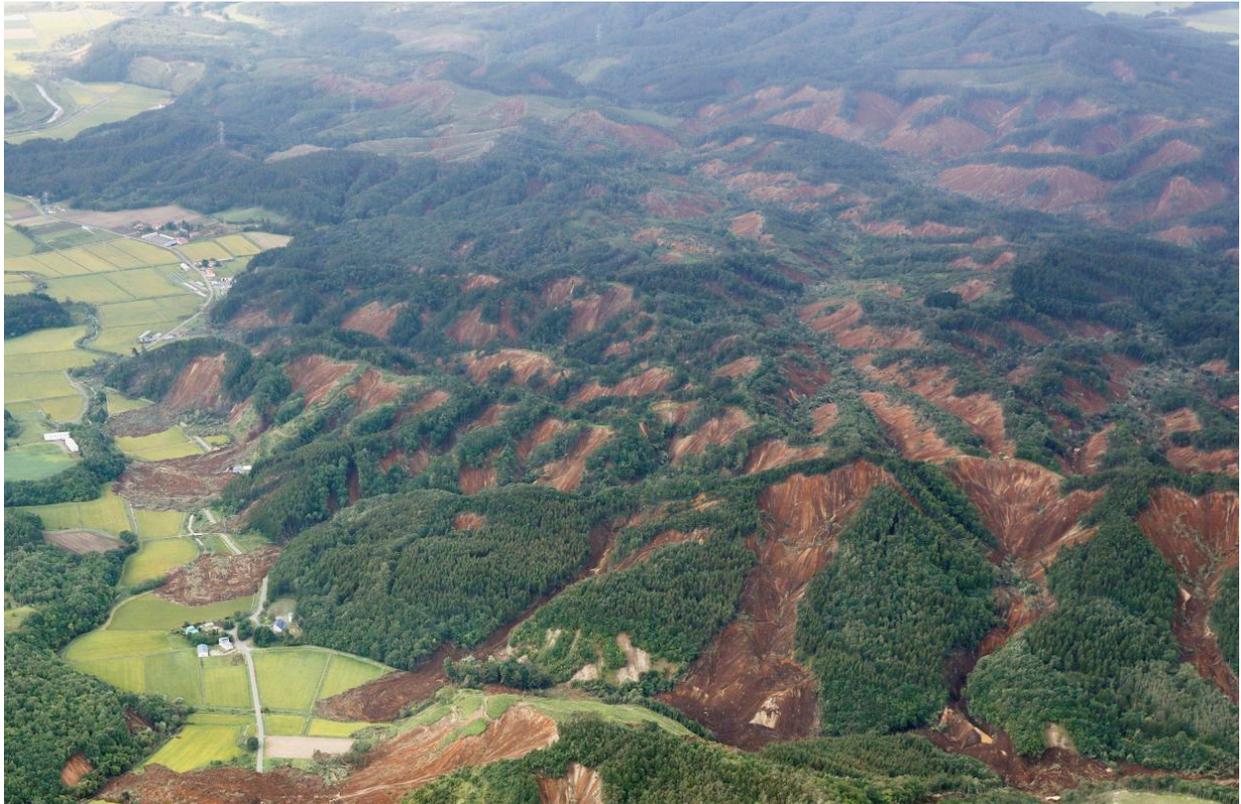
Photo 8 Landslides in Atsuma

- However, from preliminary reports, the main damage was caused by land subsidence, liquefaction, landslides, mudslides, and other geological effects.
- Resulting blackouts have hit as many as 2.95 million households.
